Our current set of charts is **Antares Charts 2018:** the following **Corrections** and **Cautions** relate to issues identified after its publication. Corrections will be reflected in our next set of charts, expected to be published in January 2020. All Corrections and Cautions are subject to the Conditions posted on this website.

Issues relating to charts in the current 2018 set:

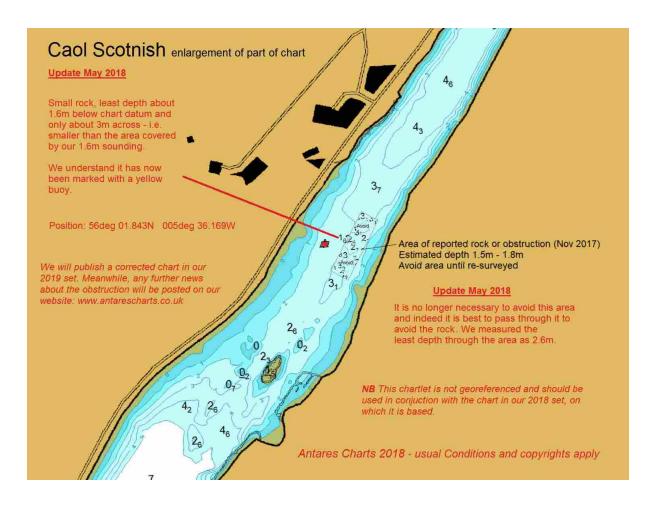
May 2018: Correction: Caol Scotnish: our 2018 chart indicated an area to avoid, where we had received reports of an uncharted rock. We have now surveyed the rock but it is just outside the marked area. A full replacement chart will be included in our next set and meanwhile an enlargement of the affected area is shown below and can be downloaded from our website. You may wish to keep it with you—it is not georeferenced for use in plotters but when used with our original chart will enable you to avoid the rock, which is 1.6m below chart datum and only about 3m across and which we understand has been marked with a yellow buoy.
