ANTARES CHARTS CORRECTIONS AND CAUTIONS 2021

Our current set of charts is **Antares Charts 2020** (there will be no 2021 set): the following **Corrections** and **Cautions** relate to issues identified after its publication. Corrections will be reflected in our next set of charts, expected to be published in January 2022. All Corrections and Cautions are subject to the Conditions posted on this website.

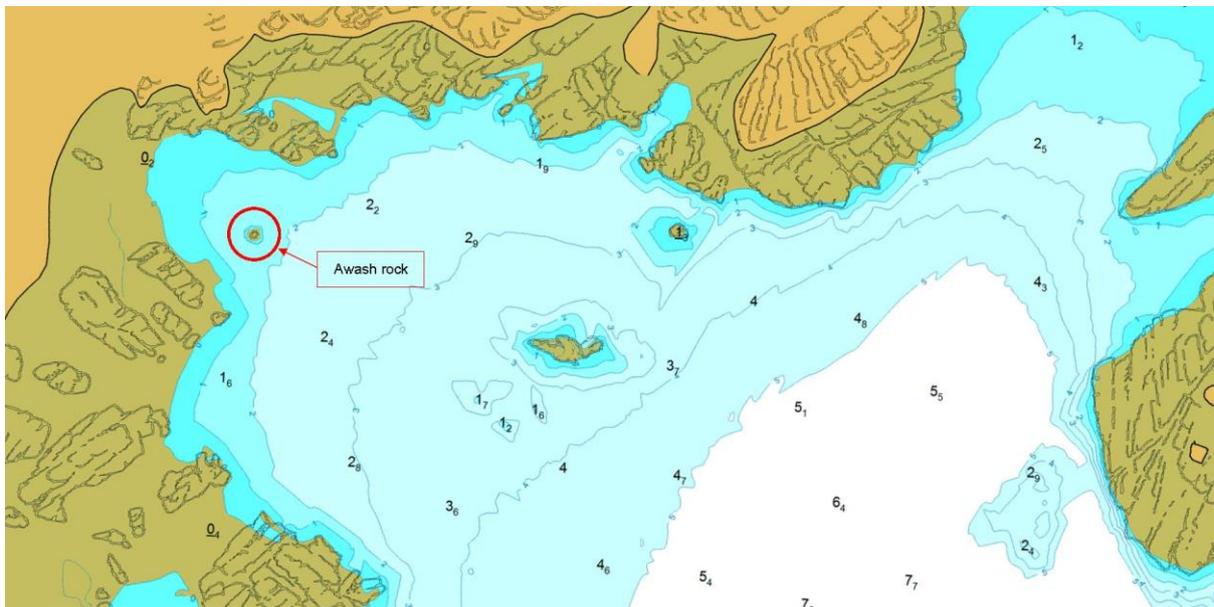
September 2021: New rock at Caolas Mor, Oronsay: one of our eagle-eyed users spotted kelp on the surface in the NW part of Caolas Mor and it turned out to be an uncharted rock that is awash at chart datum, position 56 deg 01.065 min N and 6deg 13.728 min W. It will be shown on edition 3 of chart 5600B to be published in January and is about 30m SE of the 1.2m sounding shown on earlier editions.

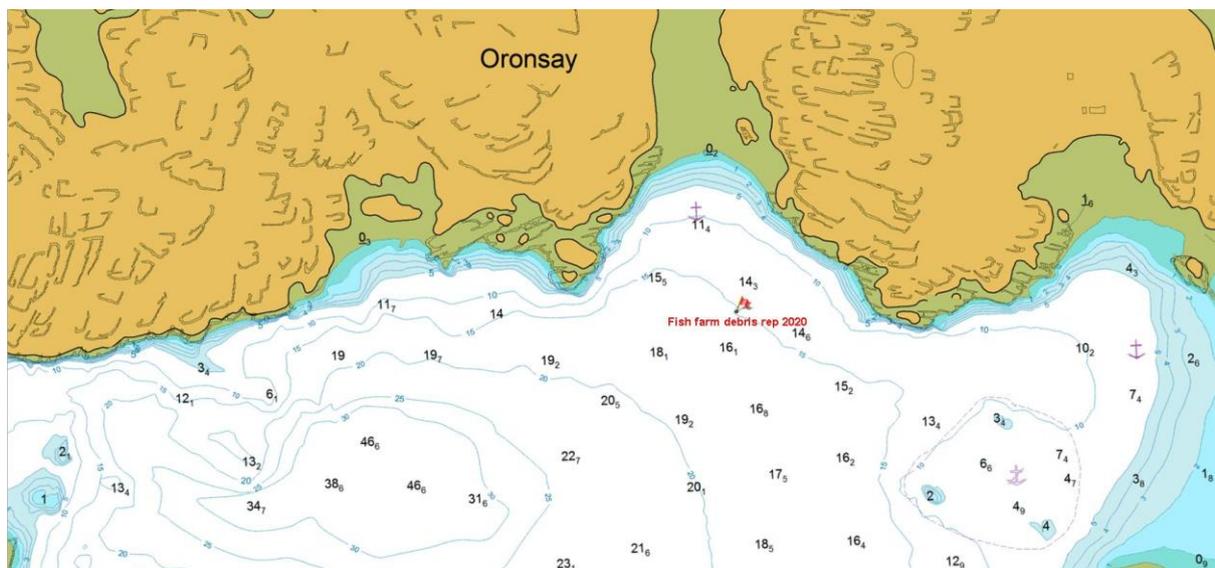
August 2020: New hazard: Loch Drumbuie: an Antares Charts subscriber recently reported the following serious underwater hazard: a heavy pile of fish farm debris comprising nets, steel poles and ropes - all well enough secured to the bottom to hold our vessel on a vertical rode against 30knots! Location, roughly on the 15m contour to the north of the Loch: 56° 39.428' N 5° 55.733' W. For convenience this position is shown on the extract of our chart:

Please note that we do not expect to be able to detect obstructions of this sort – we can only mark them when they are reported to us. And we seldom show floating fishing gear as it tends to be moved quite frequently

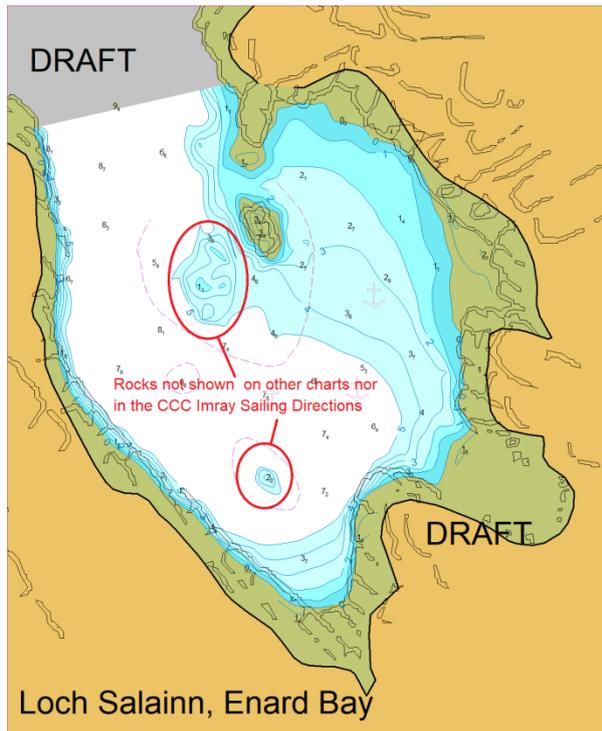
June 2021: Caution: Loch Salainn, Enard Bay. There is a large rocky area with least depth of 1.1m adjacent to the prominent drying rock and partly obstructing the channel into the loch. There is also a rock with least depth of 2.2m exactly where yachts would be likely to anchor. An image of a draft chart is reproduced below.
