## ANTARES CHARTS    CORRECTIONS AND CAUTIONS 2019

Our current set of charts is **Antares Charts 2018**: the following **Corrections** and **Cautions** relate to issues identified after its publication. Corrections will be reflected in our next set of charts, expected to be published in January 2020. All Corrections and Cautions are subject to the Conditions posted on this website.

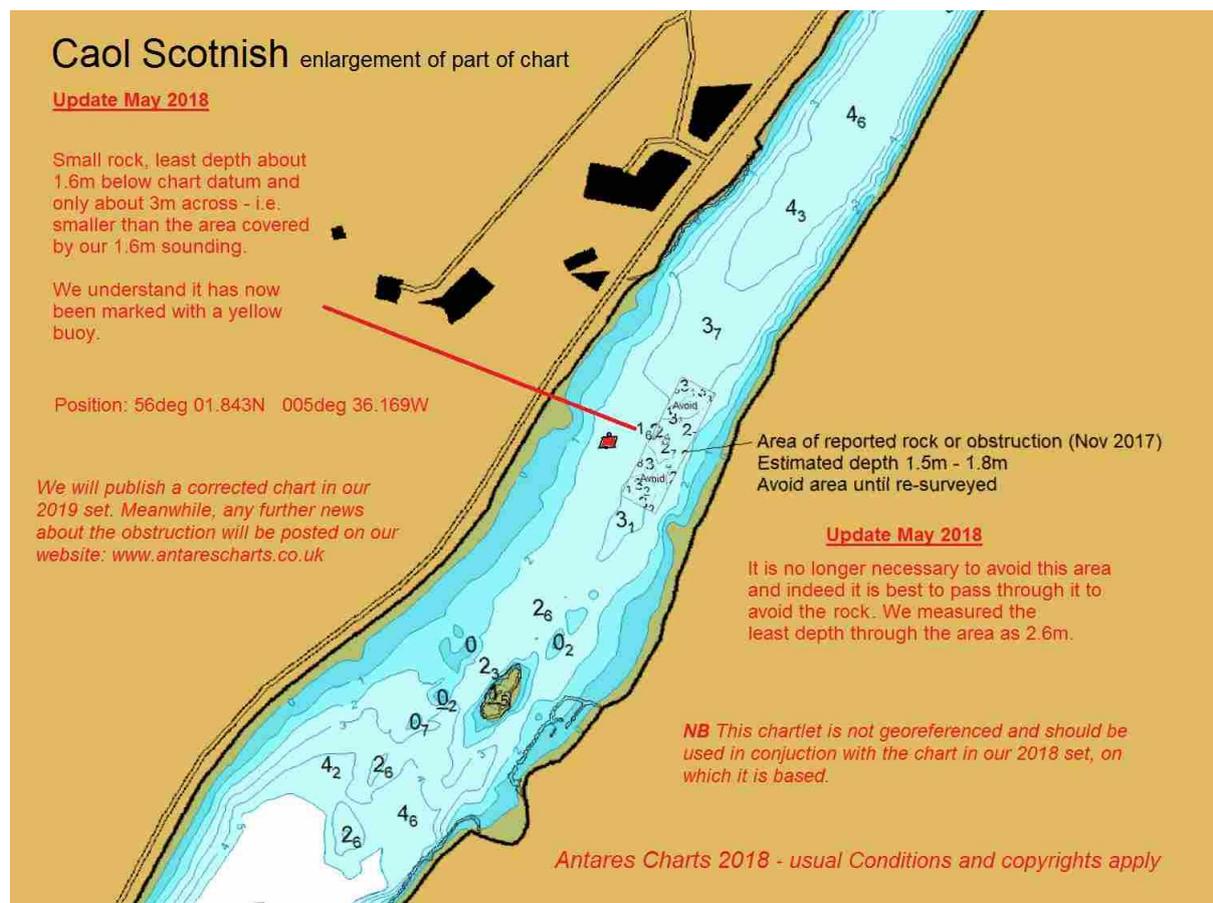
You will need to zoom in to read this, or download it from our website:

**May 2018: Correction: Caol Scotnish:** our 2018 chart indicated an area to avoid, where we had received reports of an uncharted rock. We have now surveyed the rock but it is just outside the marked area. A full replacement chart will be included in our next set and meanwhile an enlargement of the affected area is shown below and can be downloaded from our website. You may wish to keep it with you—it is not georeferenced for use in plotters but when used with our original chart will enable you to avoid the rock, which is only about 3m across and which we understand has been marked with a yellow buoy.
